LITHIUM-ION BATTERY FIRES AND EMISSIONS CHARACTERIZATION

REPORT

November 2024

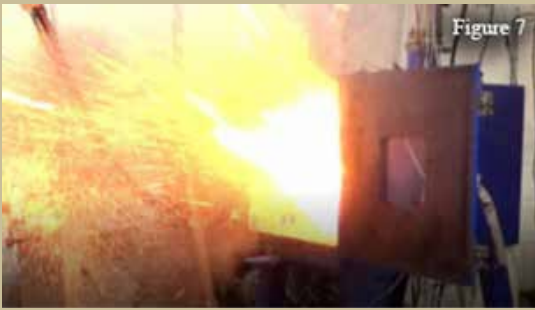
Figure 7 (Left): Battery Test #3, where internal pressure from Li battery thermal runaway forced the blast chamber door to open.

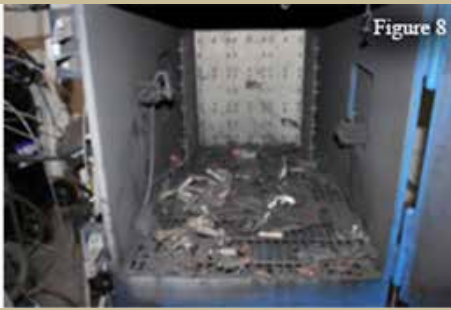
Figure 8 (Right): Remains of Li-ion battery in blast chamber post-thermal runaway.

- In each test, significant battery weight loss, ranging from 44% to 63%, was observed post-thermal runaway.
